Preliminary Geotechnical Investigation

Shelton Studio Ranch

Re: **Preliminary Geotechnical Investigation Report  
Shelton Studio Ranch  
850 Shelton Rd  
Golden, CO**

Project No: D18G158

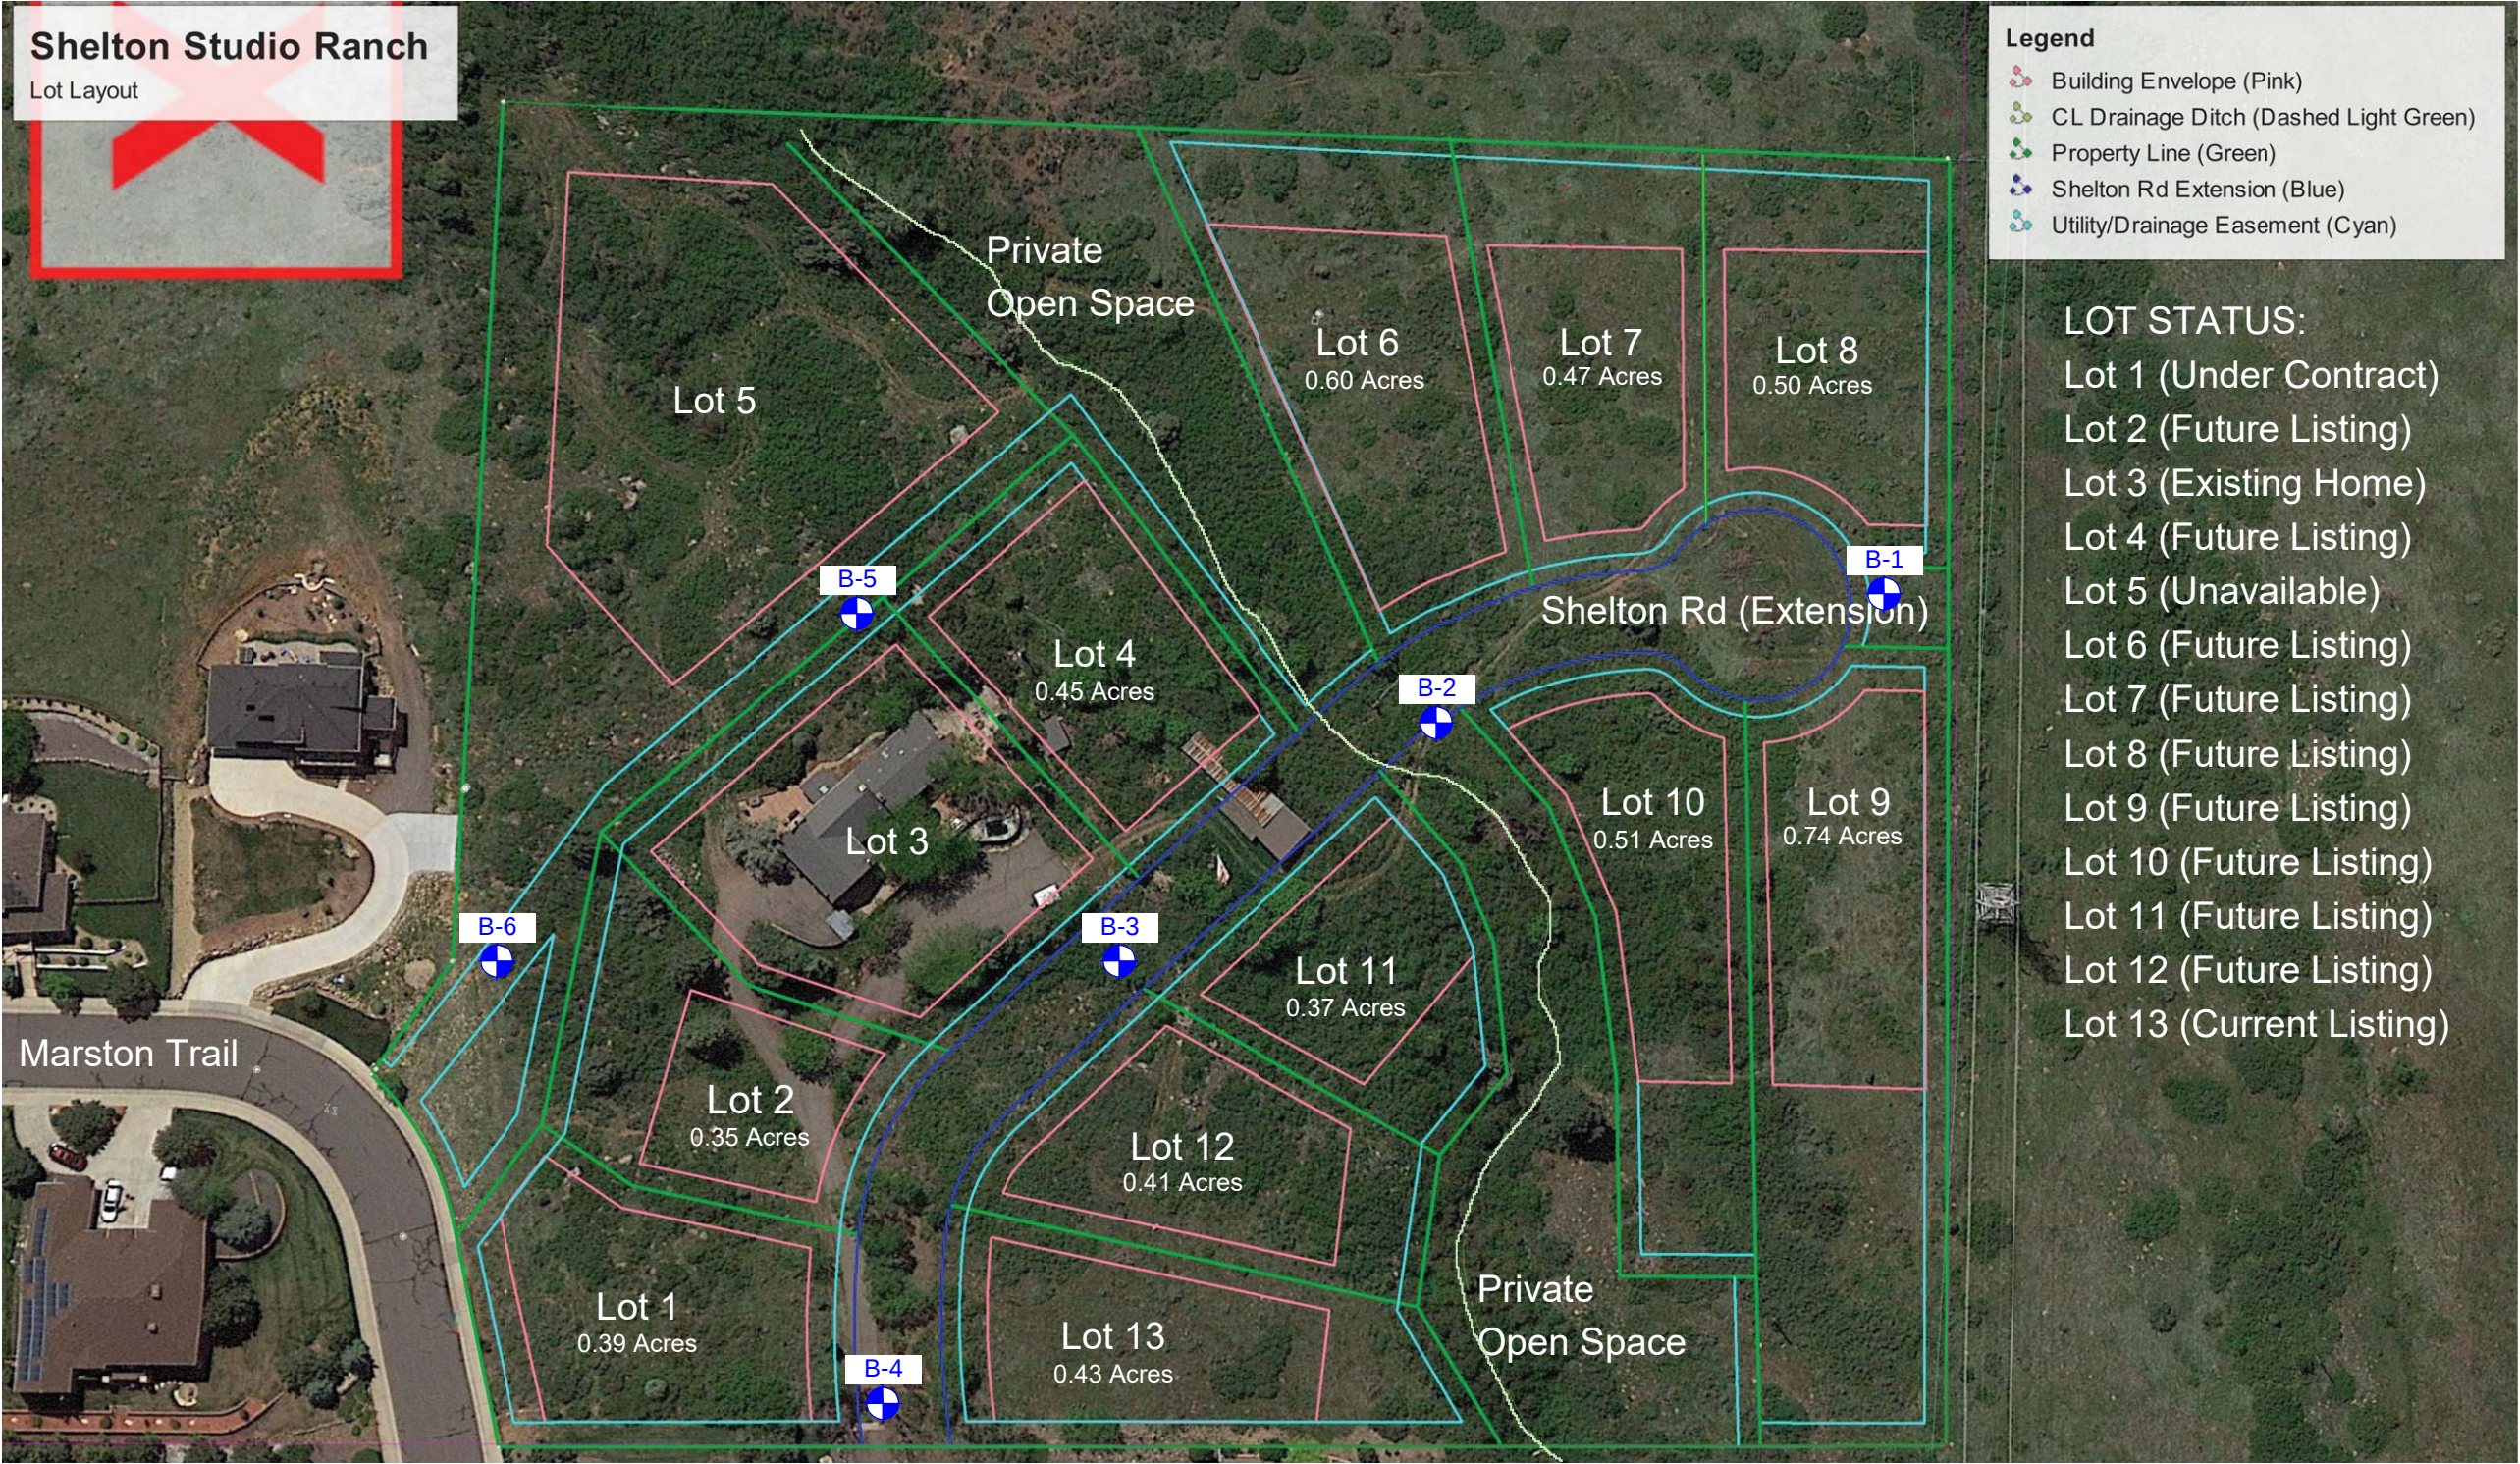
| <b>Boring Location Plan</b> |

Shelton Studio Ranch  
850 Shelton Rd.  
Golden CO

Subsurface conditions were investigated by drilling six borings to depths of up to 20-ft each, from the existing grade at the locations indicated on the Site Map. The borings were advanced using a 4-inch diameter continuous flight auger powered by a CME-45 drilling rig. Samples were taken at selected intervals using a Standard split spoon and a California ring sampler, which was driven into the soil by dropping a 140-pound hammer through a free fall of 30 inches. The number of blows required to drive the sampler into the soil is known as a penetration test. The number of blows required for the sampler to penetrate 12 inches is evaluated and gives an indication of the consistency or relative density of the soils and bedrock encountered. The results of the
